Assisted roofing

Columbia Roofing and Sheet Metal restores three roof systems on Town Center Village in Oregon

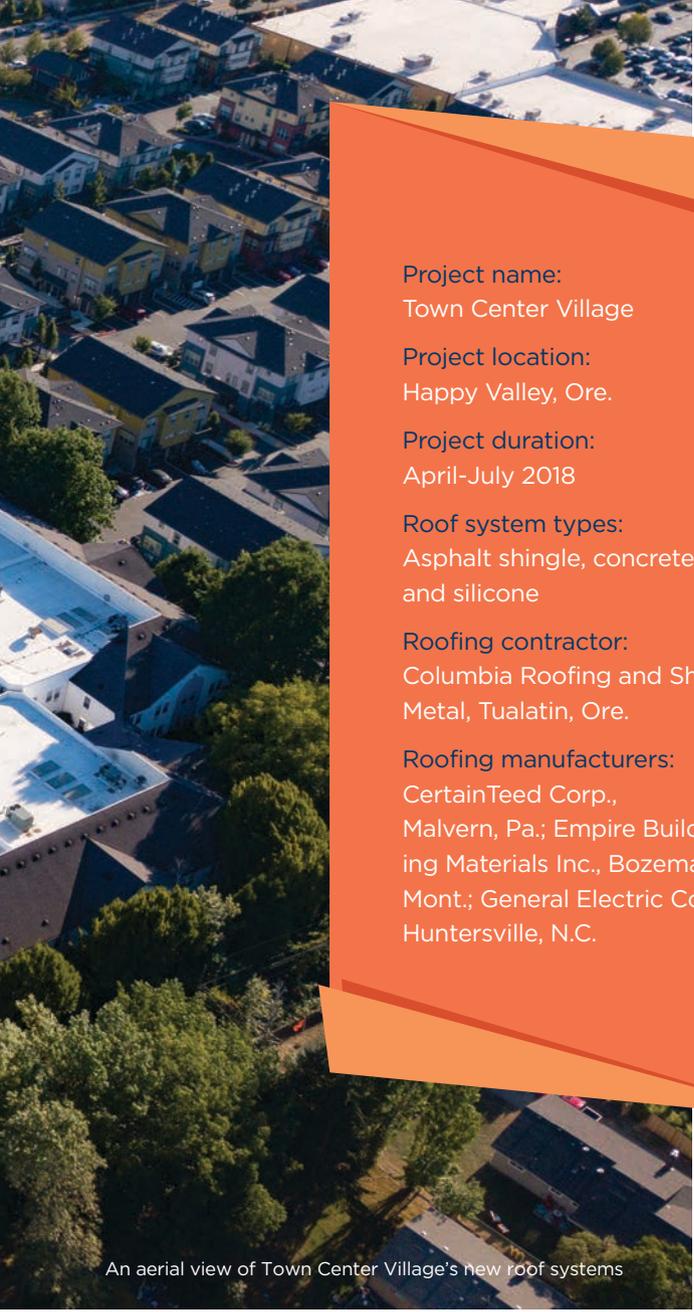
An aerial view of Town Center Village's new roof systems
